## TEST REPORT

No. : GZIN2101003787CM

Sample Name : Co extrusion WPC Decking - Proshield

Test Item: Striker Impacted by a Falling Weight

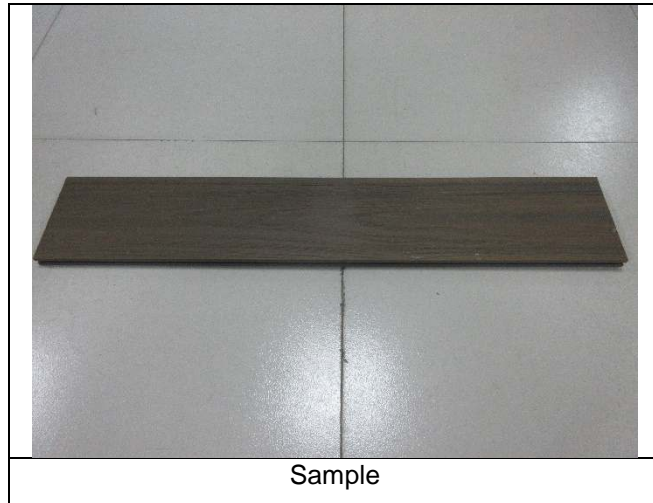
Original Sample Photo:

Material and Mark : WPC

Sample Description: See photo
